Re: Dona Ana County South Central Treatment Plant; Major Municipal; SIC 4952; NPDES Compliance Evaluation Inspection; NM0030490; January 27, 2017

NPDES Compliance Inspection Report

Doña Ana County - South Central Regional Wastewater Treatment Plant
NPDES Permit NM0030490
Compliance Evaluation Inspection
January 27, 2017
Page 1 of 7

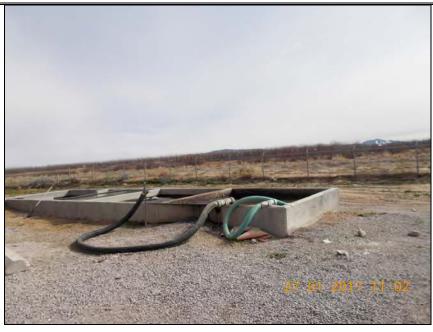
NMED/.SWQB Official Photograph Log Photo #3						
Photographer: B. Cooney Date: 01/27/2017 Time: 11:02 Hours						
City/County: Vado / Doña Ana County		State: New Mexico				
Location: Doña Ana County - South Central Regional Wastewater Treatment Plant						
Subject: Septage Receiving station current	Subject: Septage Receiving station currently has no monitoring apparatus.

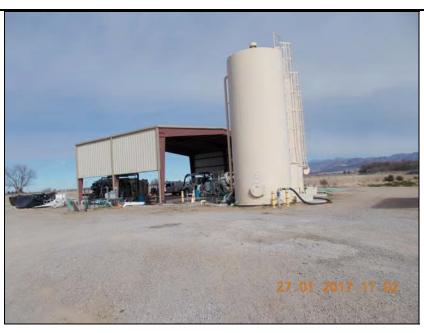
NMED/SWQB Official Photograph Log Photo #4							
Photographer: B. Cooney Date: 01/27/2017 Time: 11:02 Hours							
City/County: Vado / Doña Ana County		State: New Mexico					
Location: Doña Ana County - South Central Regional Wastewater Treatment Plant							
Subject: Septage holding tanks are used for storage of incoming septage before being sent to the aeration basin for treatment. The sludge belt press for solids after aeration is also seen in covered area.

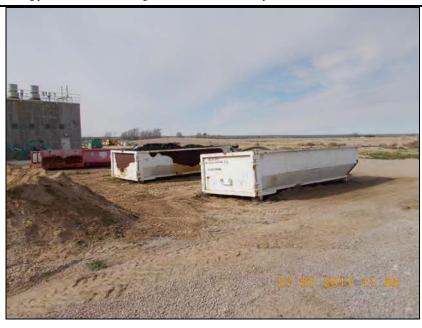
NMED/SWQB Official Photograph Log Photo # 6					
Photographer: B. Cooney	Date: 01/27/2017	Time: 11:05 Hours			
City/County: Vado / Doña Ana County		State: New Mexico

Subject: Roll-off dumpsters used for hauling processed sludge to the landfill. The area was clear of debris. The dumpsters are sitting on bare ground, without secondary containment. The majority of the treatment plant around the process area is bare ground. The potential exists for infiltration on this site to ground water for any spilled waste. The entire areas could benefit from being paved and bermed. This segment of the Rio Grande is impaired for E.coli bacteria.

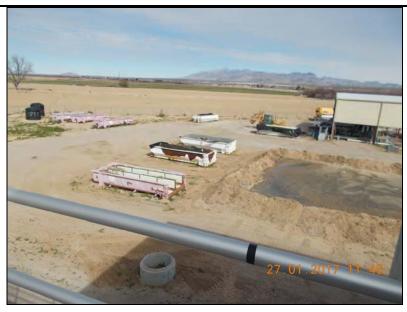
NMED/SWQB Official Photograph Log Photo # 7						
Photographer: B. Cooney	Date: 01/27/2017	Time: 11:45 Hours				
City/County: Vado / Doña Ana County		State: New Mexico

Subject: Another view of the roll-off dumpsters and the septage back up holding pond. From this higher point of view it appeared that the berms were recently enforced with dirt, based on the tracks around the berms.

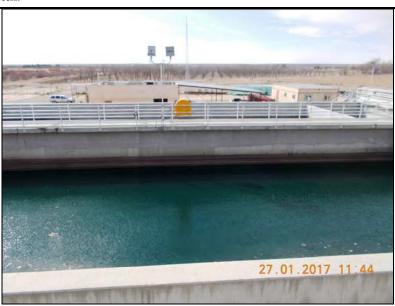
NMED/SWQB Official Photograph Log Photo # 10				
Photographer: B. Cooney	Date: 01/27/2017	Time: 11:44 Hours		
City/County: Vado / Doña Ana County		State: New Mexico

Subject: North Aeration basin, septic waste is sent through this basin. The bright blue of this basin is typical of the products used in porta-potties as an antiseptic and odor reducer. The chemicals in these products as well as the unknown constitution of the septage received at the facility appears to interfere with the biological growth necessary for an activated sludge treatment process.

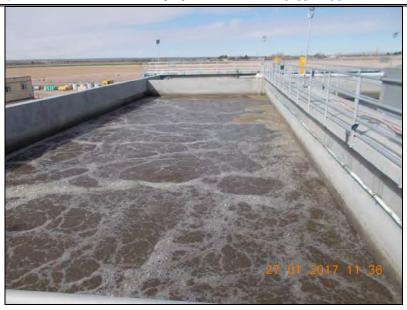
NMED/SWQB Official Photograph Log Photo # 11				
Photographer: B. Cooney	Date: 01/27/2017	Time: 11:36 Hours		
City/County: Vado / Doña Ana County		State: New Mexico

Subject: South Aeration Basin, domestic waste is treated in this basin. The air diffusers were on and no dead spots (areas where diffusers were not reaching) were observed. The sludge in the basin appeared slightly less rich brown than optimal and there was evidence of grease in the basins. The grease is likely a result of residential cooking. As part of a pretreatment program, it may be valuable to include an educational pamphlet to residents discouraging pouring grease down the drain.

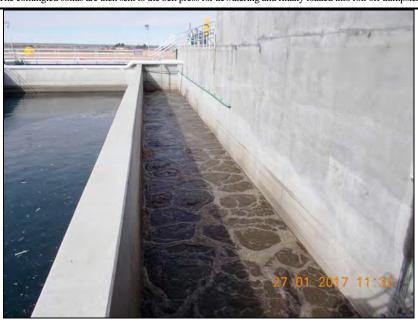
NMED/SWQB Official Photograph Log Photo # 12						
Photographer: B. Cooney Date: 01/27/2017 Time: 11:32 Hours						
City/County: Vado / Doña Ana County State: New Mexico						
Location: Doña Ana County - South Central Regions	al Wastewater Treatment Plant

Subject: The sludge aerobic (aerated) digester on the far north of the aeration basins. Sludge from both aerated basins, is sent through this sludge digerser where aeration occurs 24 hours / 7 days a week. The comingled solids are then sent to the belt press for dewatering and finally loaded into roll off dumpsters for disposal at the landfill.

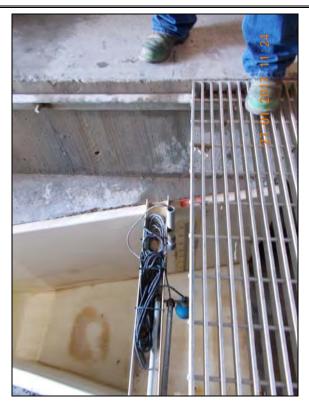
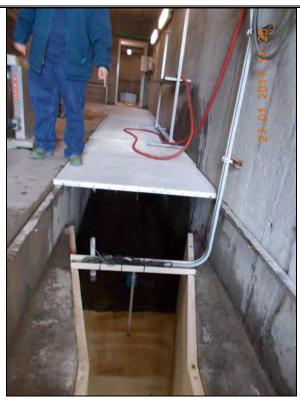
NMED/SWQB Official Photograph Log Photo # 15 & 16					
Photographer: B. Cooney	Date: 01/27/2017	Time:11:24 & 11:25 Hours			
City/County: Vado / Doña Ana County		State: New Mexico

Subject: Effluent Weir and Flow measurement. Parshall Flume & Ultrasonic Sensor (another view). The staff gage is on the wrong side of the flume for operators to see easily.

- 1. The flow meter consists of an 18 inch Parshall Flume and staff gauge with a backup ultrosonic sensor. The staff gauge is checked against the ultrasonic sensor on a quarterly basis. It was observed in the facility records that many of those checks were done at zero discharge. It is suggested that when there is zero flow, that an additional check be done on that day when flow is present.

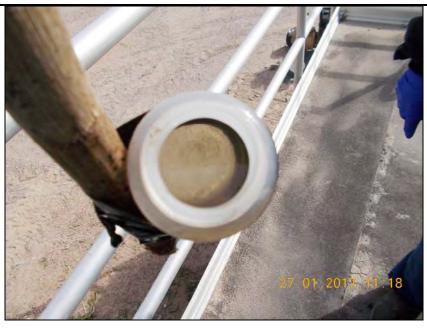
NMED/SWQB Official Photograph Log Photo # 18					
Photographer: B. Cooney	Date: 01/27/2017	Time: 11:18 Hours			
City/County: Vado / Doña Ana County State: New Mexico					
Location: Doña Ana County - South Central Regional Wastewater Treatment Plant					
Subject: Effluent water past the ultraviole	Subject: Effluent water past the ultraviolet disinfection system. Though the bottle is stained it was evident the water was slightly turbid with floating solids.

- 1. Floating solids were observed in effluent samples taken at the end of the Ultraviolet Disinfection treatment system.
- 2. No effluent exceedences reported on the Discharge Monitoring Reports for the six months prior to this inspection.

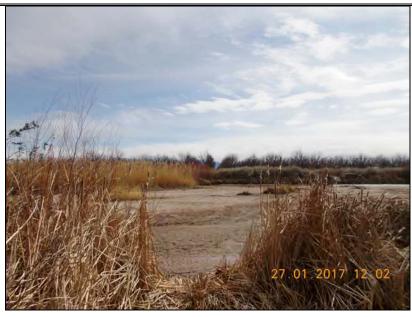
NMED/SWQB Official Photograph Log Photo # 19					
Photographer: B. Cooney Date: 01/27/2017 Time: 12:02 Hours					
City/County: Vado / Doña Ana County		State: New Mexico			
Location: Doña Ana County - South Co	ntral Regional Wastewater Treatment Plant				
Subject: Rio Grande at the outfall, upstro	eam the river was dry at the time of this inspection. The WW	VTP effluent created a perennial flow including pools.
